# **Draft Local Hazard Mitigation Plan**

## **Timber Cove County Water District**

**Timber Cove County Water District**  
22098 Lyons Ct,  
Jenner, CA, 95450

**BKF, Inc.**  
100 Franklin St #4c,  
Oakland, CA 94612

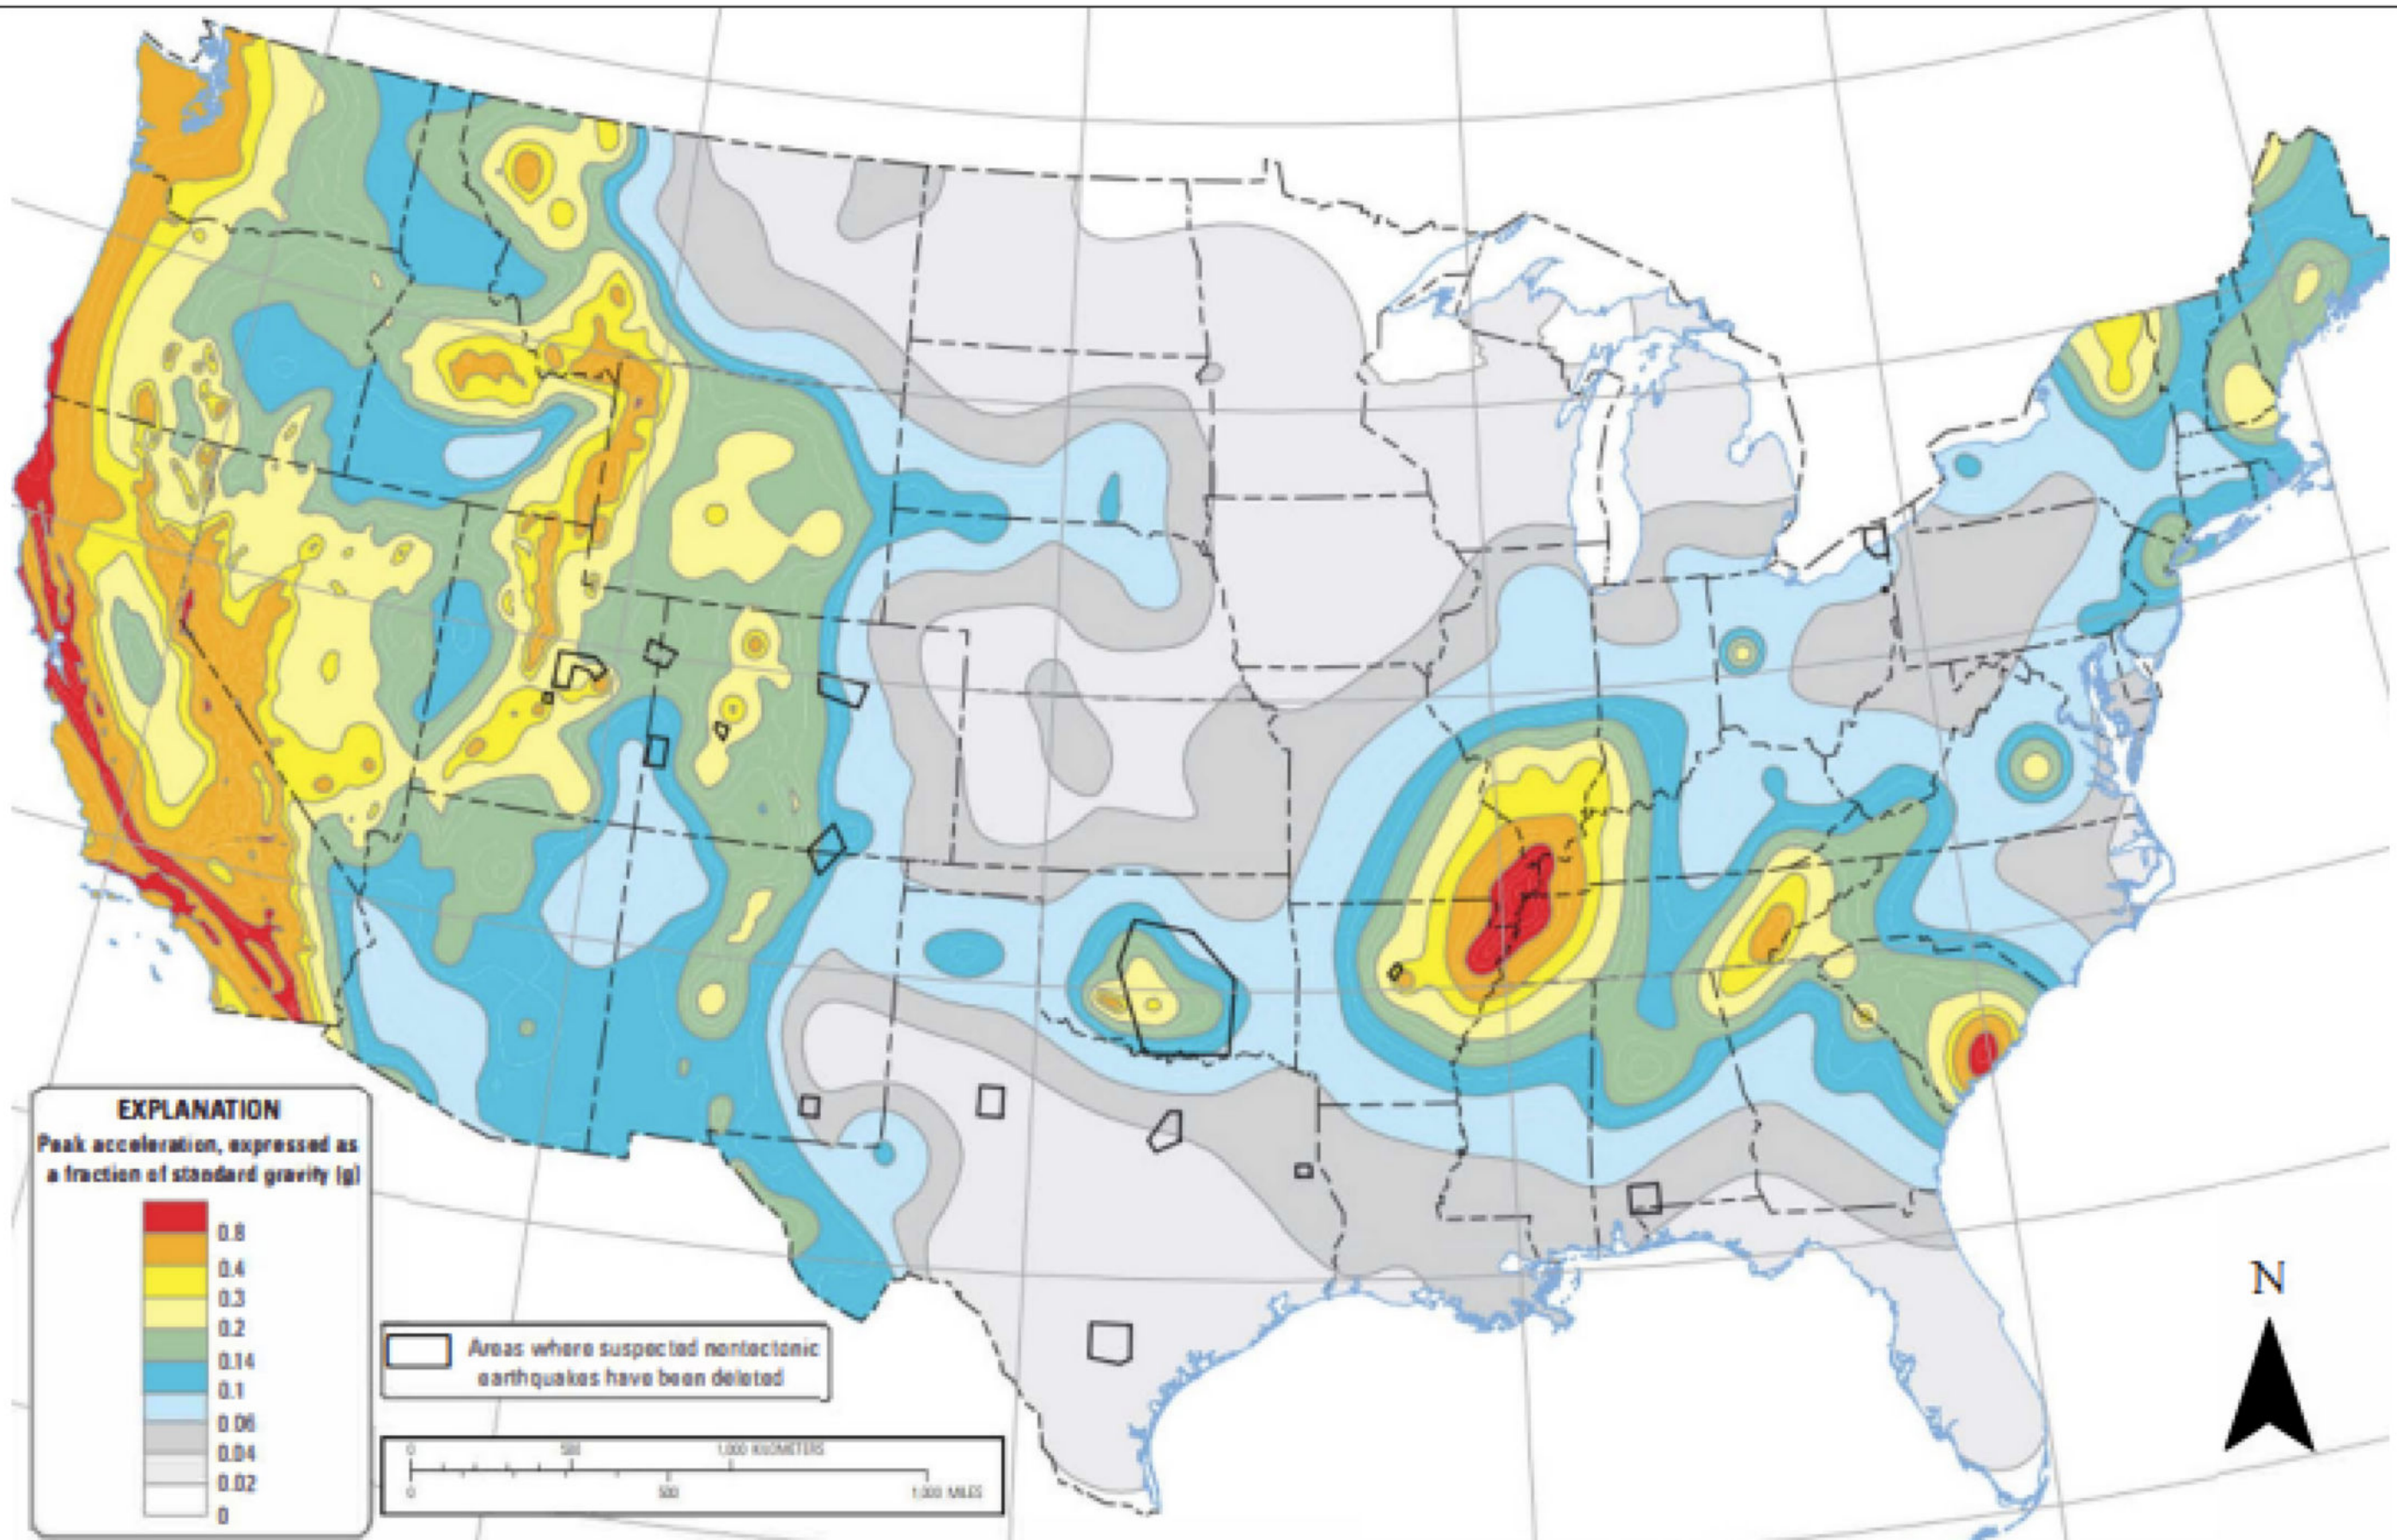
# Exhibit 2 - Earthquake Probability Map (Peak Acceleration (%g) with 2% Probability of Exceedance in 50 Years)

Source: USGS Earthquake Probability Map

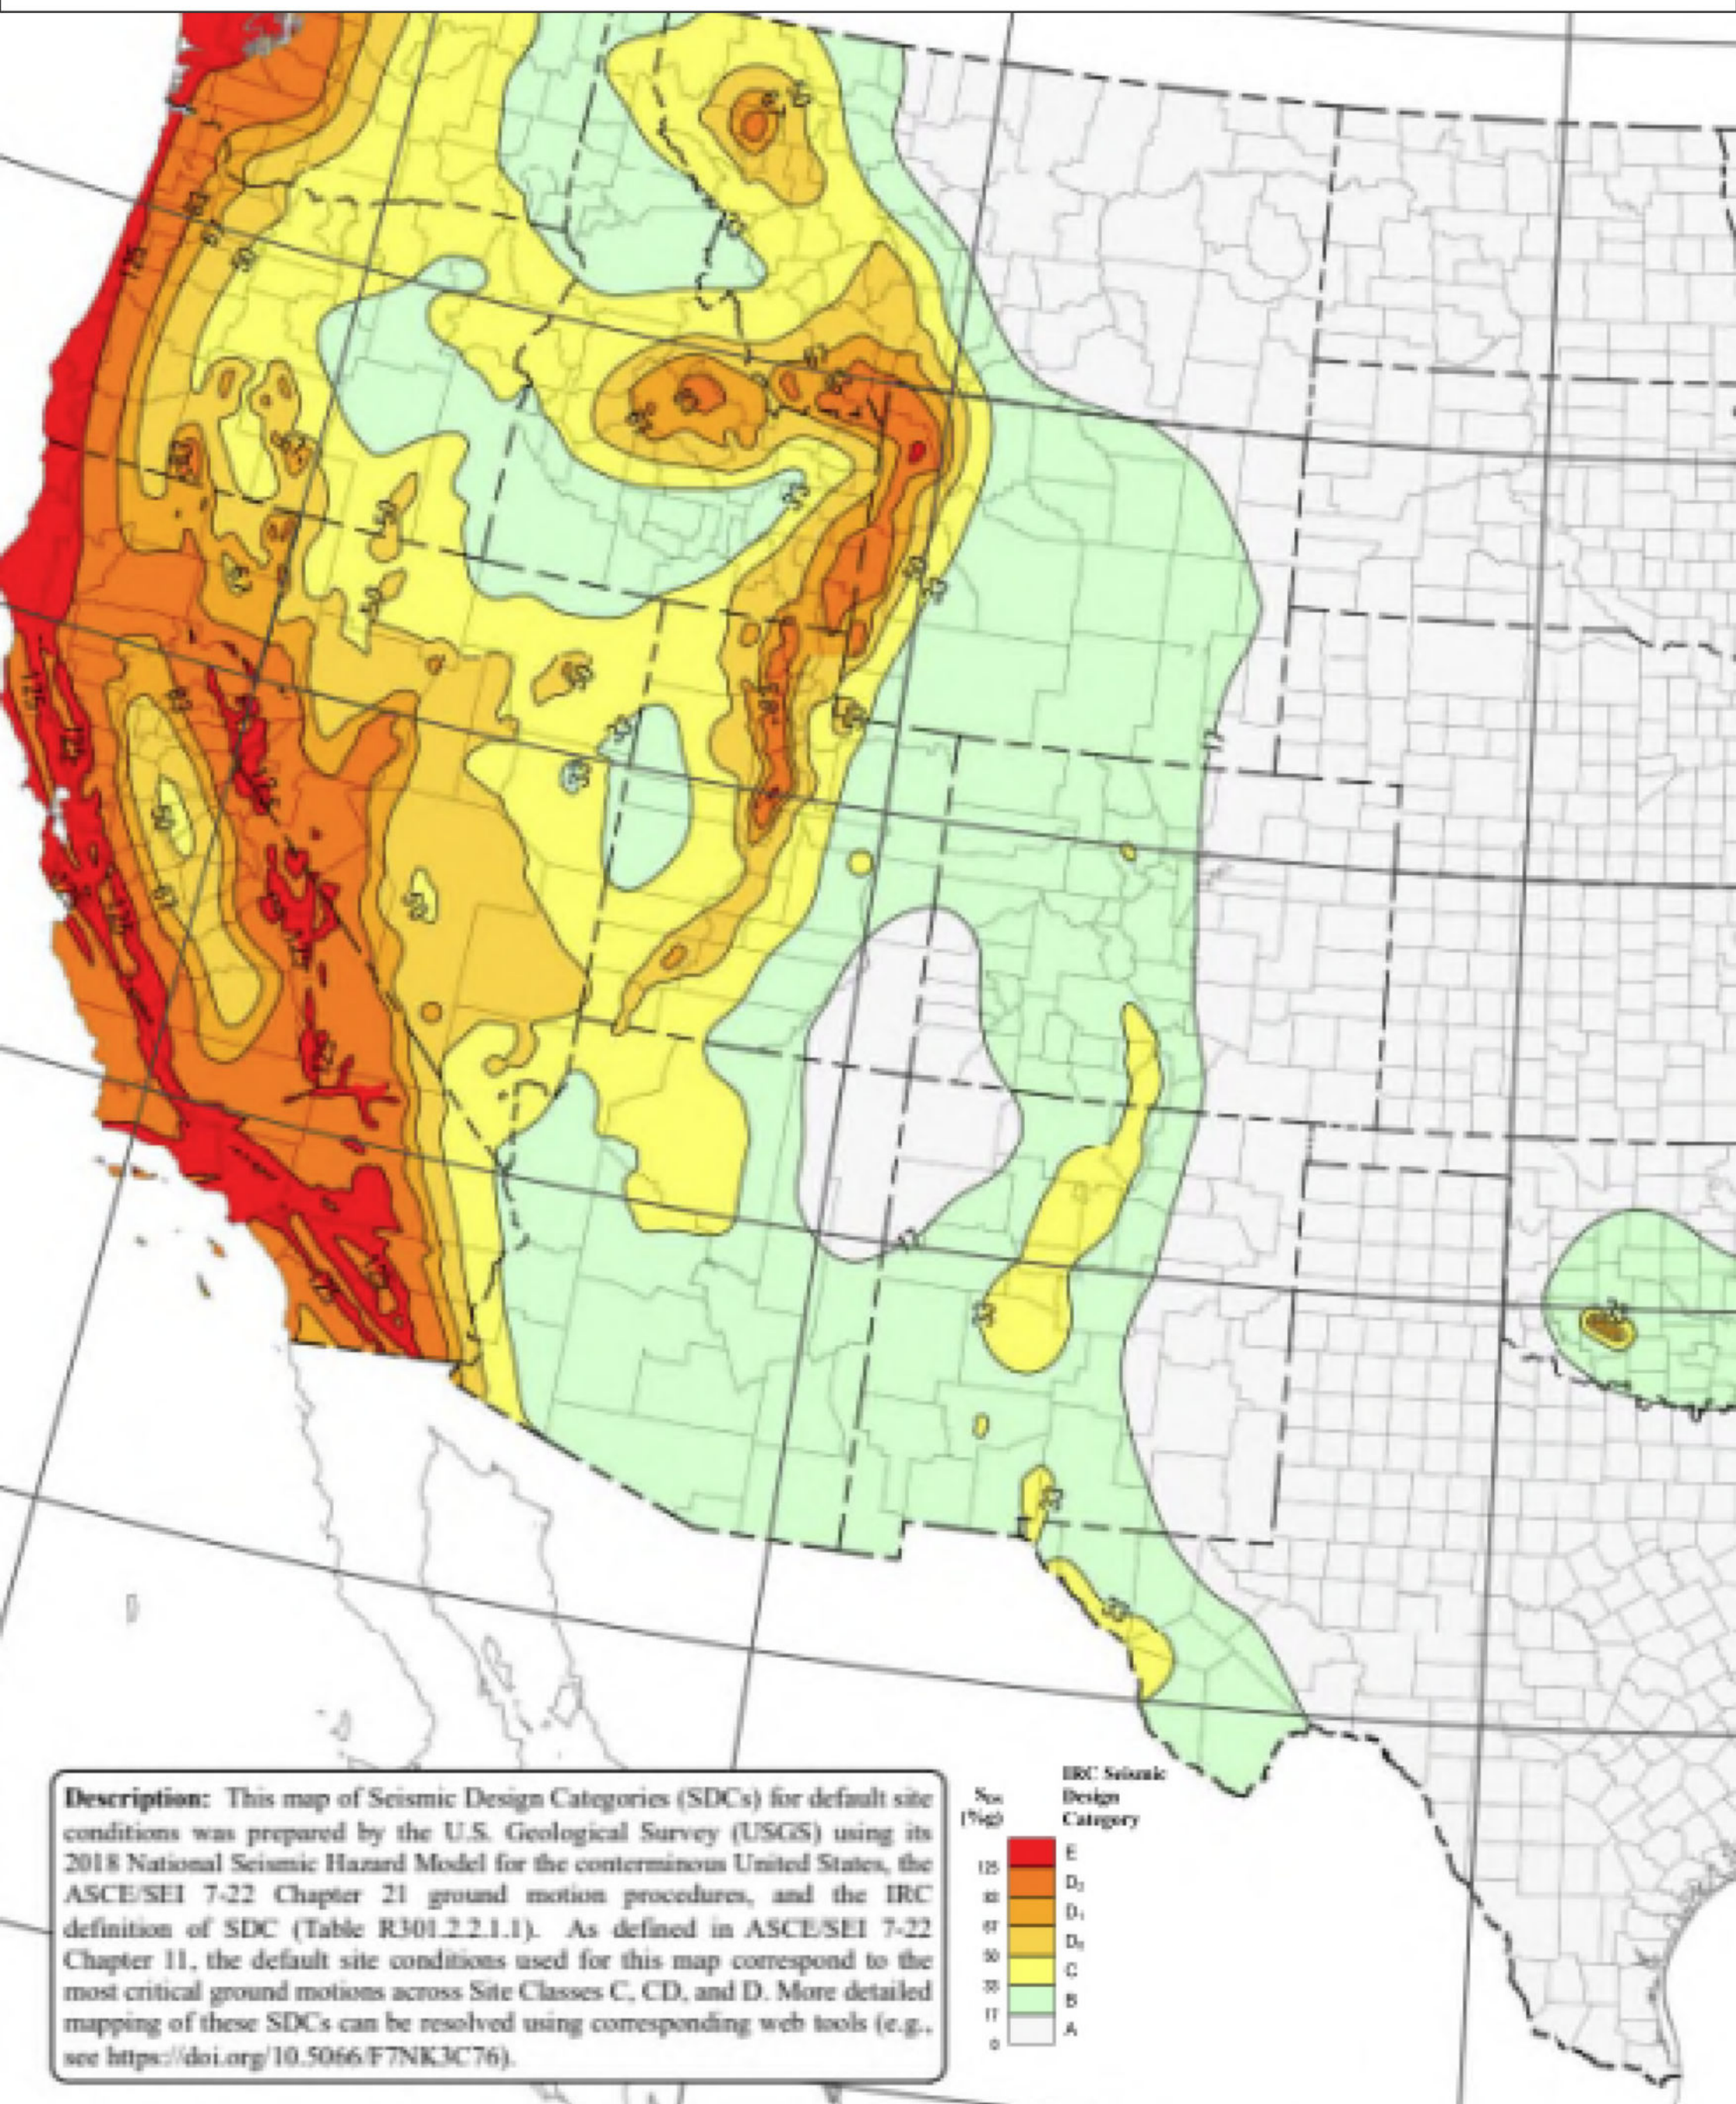
# Exhibit 3 - FEMA Earthquake Western United States

are color/alphabetically coded on the FEMA Hazard Map ranging from “A/White” denoting the lowest probability of experiencing damage to “E/Red” being near major active faults capable of producing the most intense ground shaking. Refer to Exhibit 3, *FEMA Earthquake Hazard Map for Western United States*. The map shows the range of earthquake severity of the Western United States.

Source: FEMA Seismic Design Category Maps for 2024 IRC

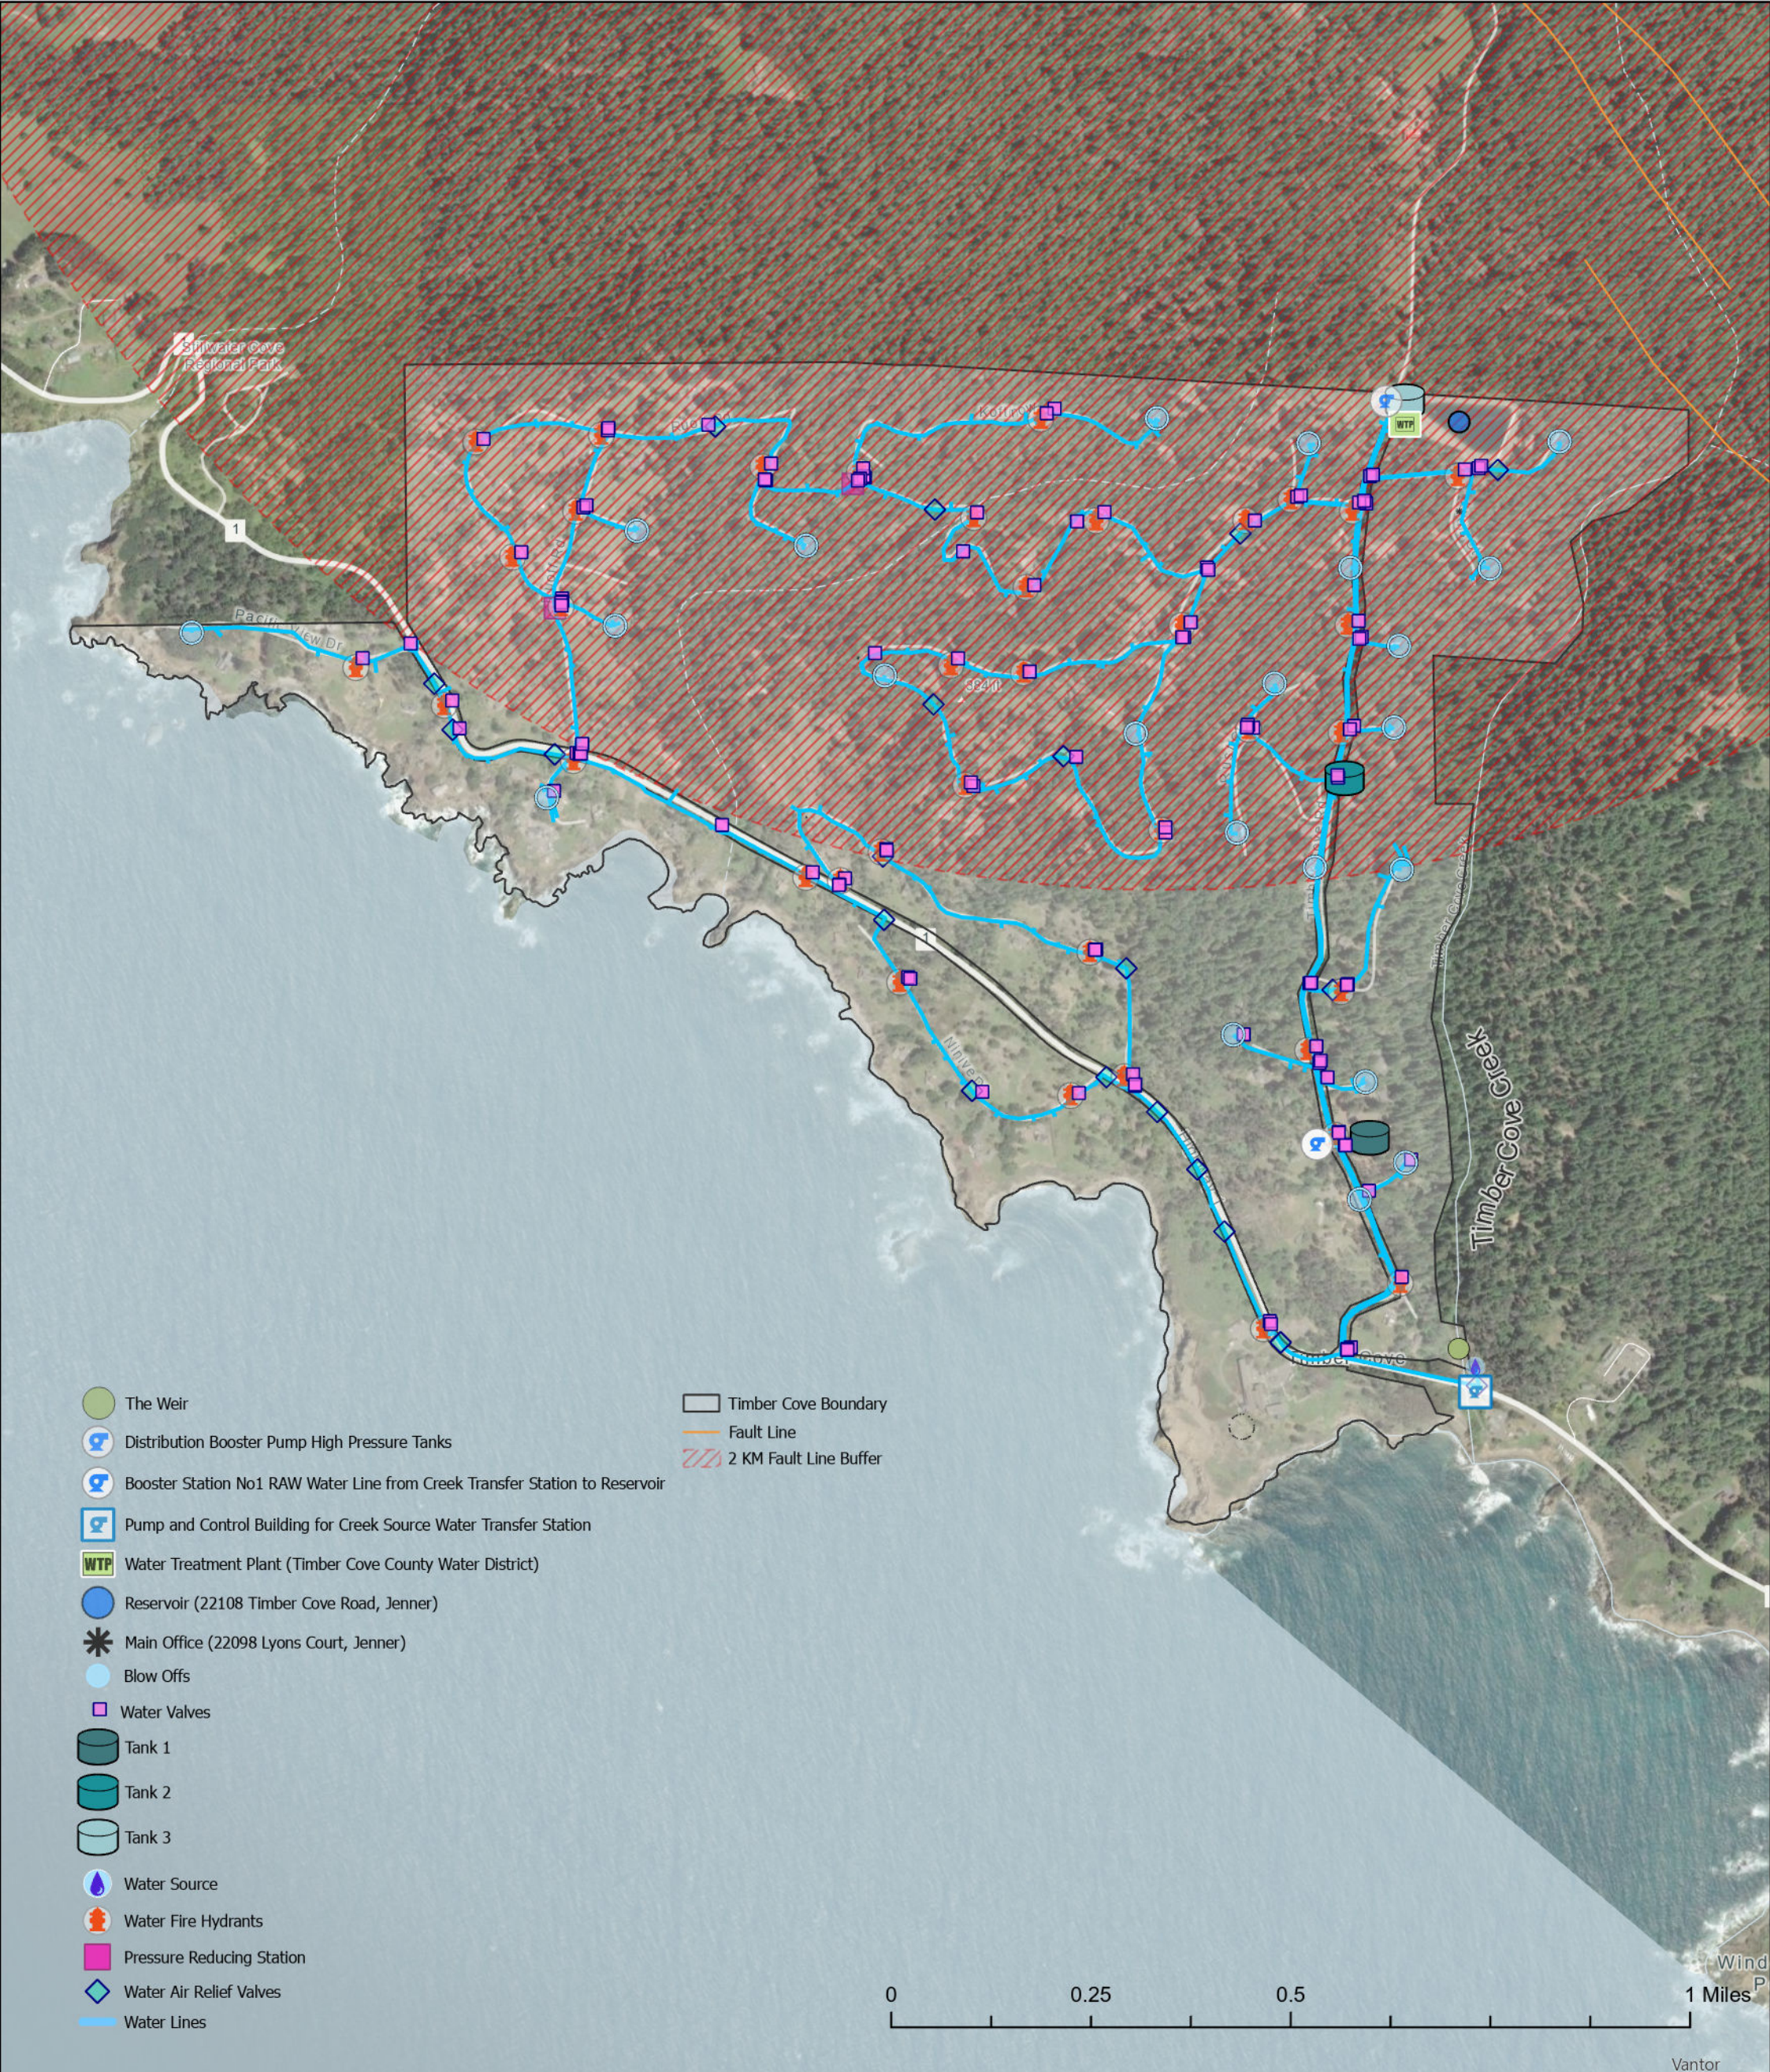
# Exhibit 4 - Earthquake Zones Adjacent to Timber Cove

Source: CalOES 2025

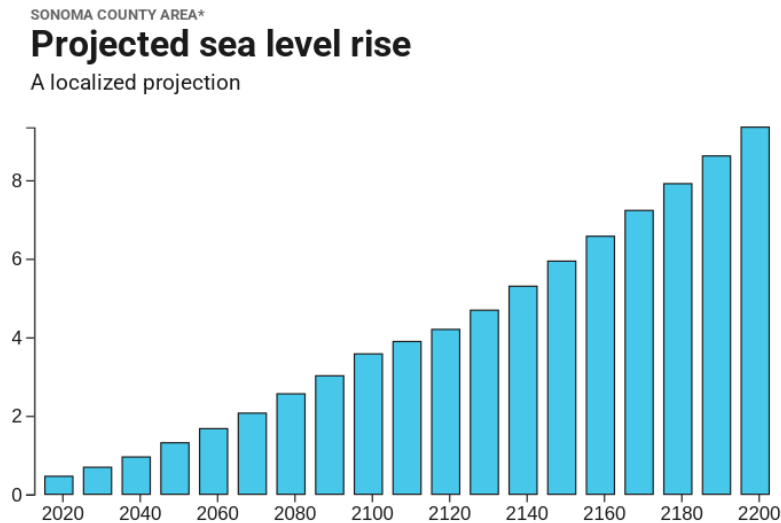
**Figure 1: Sonoma County Area Projected Sea Level Rise**

Source: Climate Central, <https://riskfinder.climatecentral.org/>

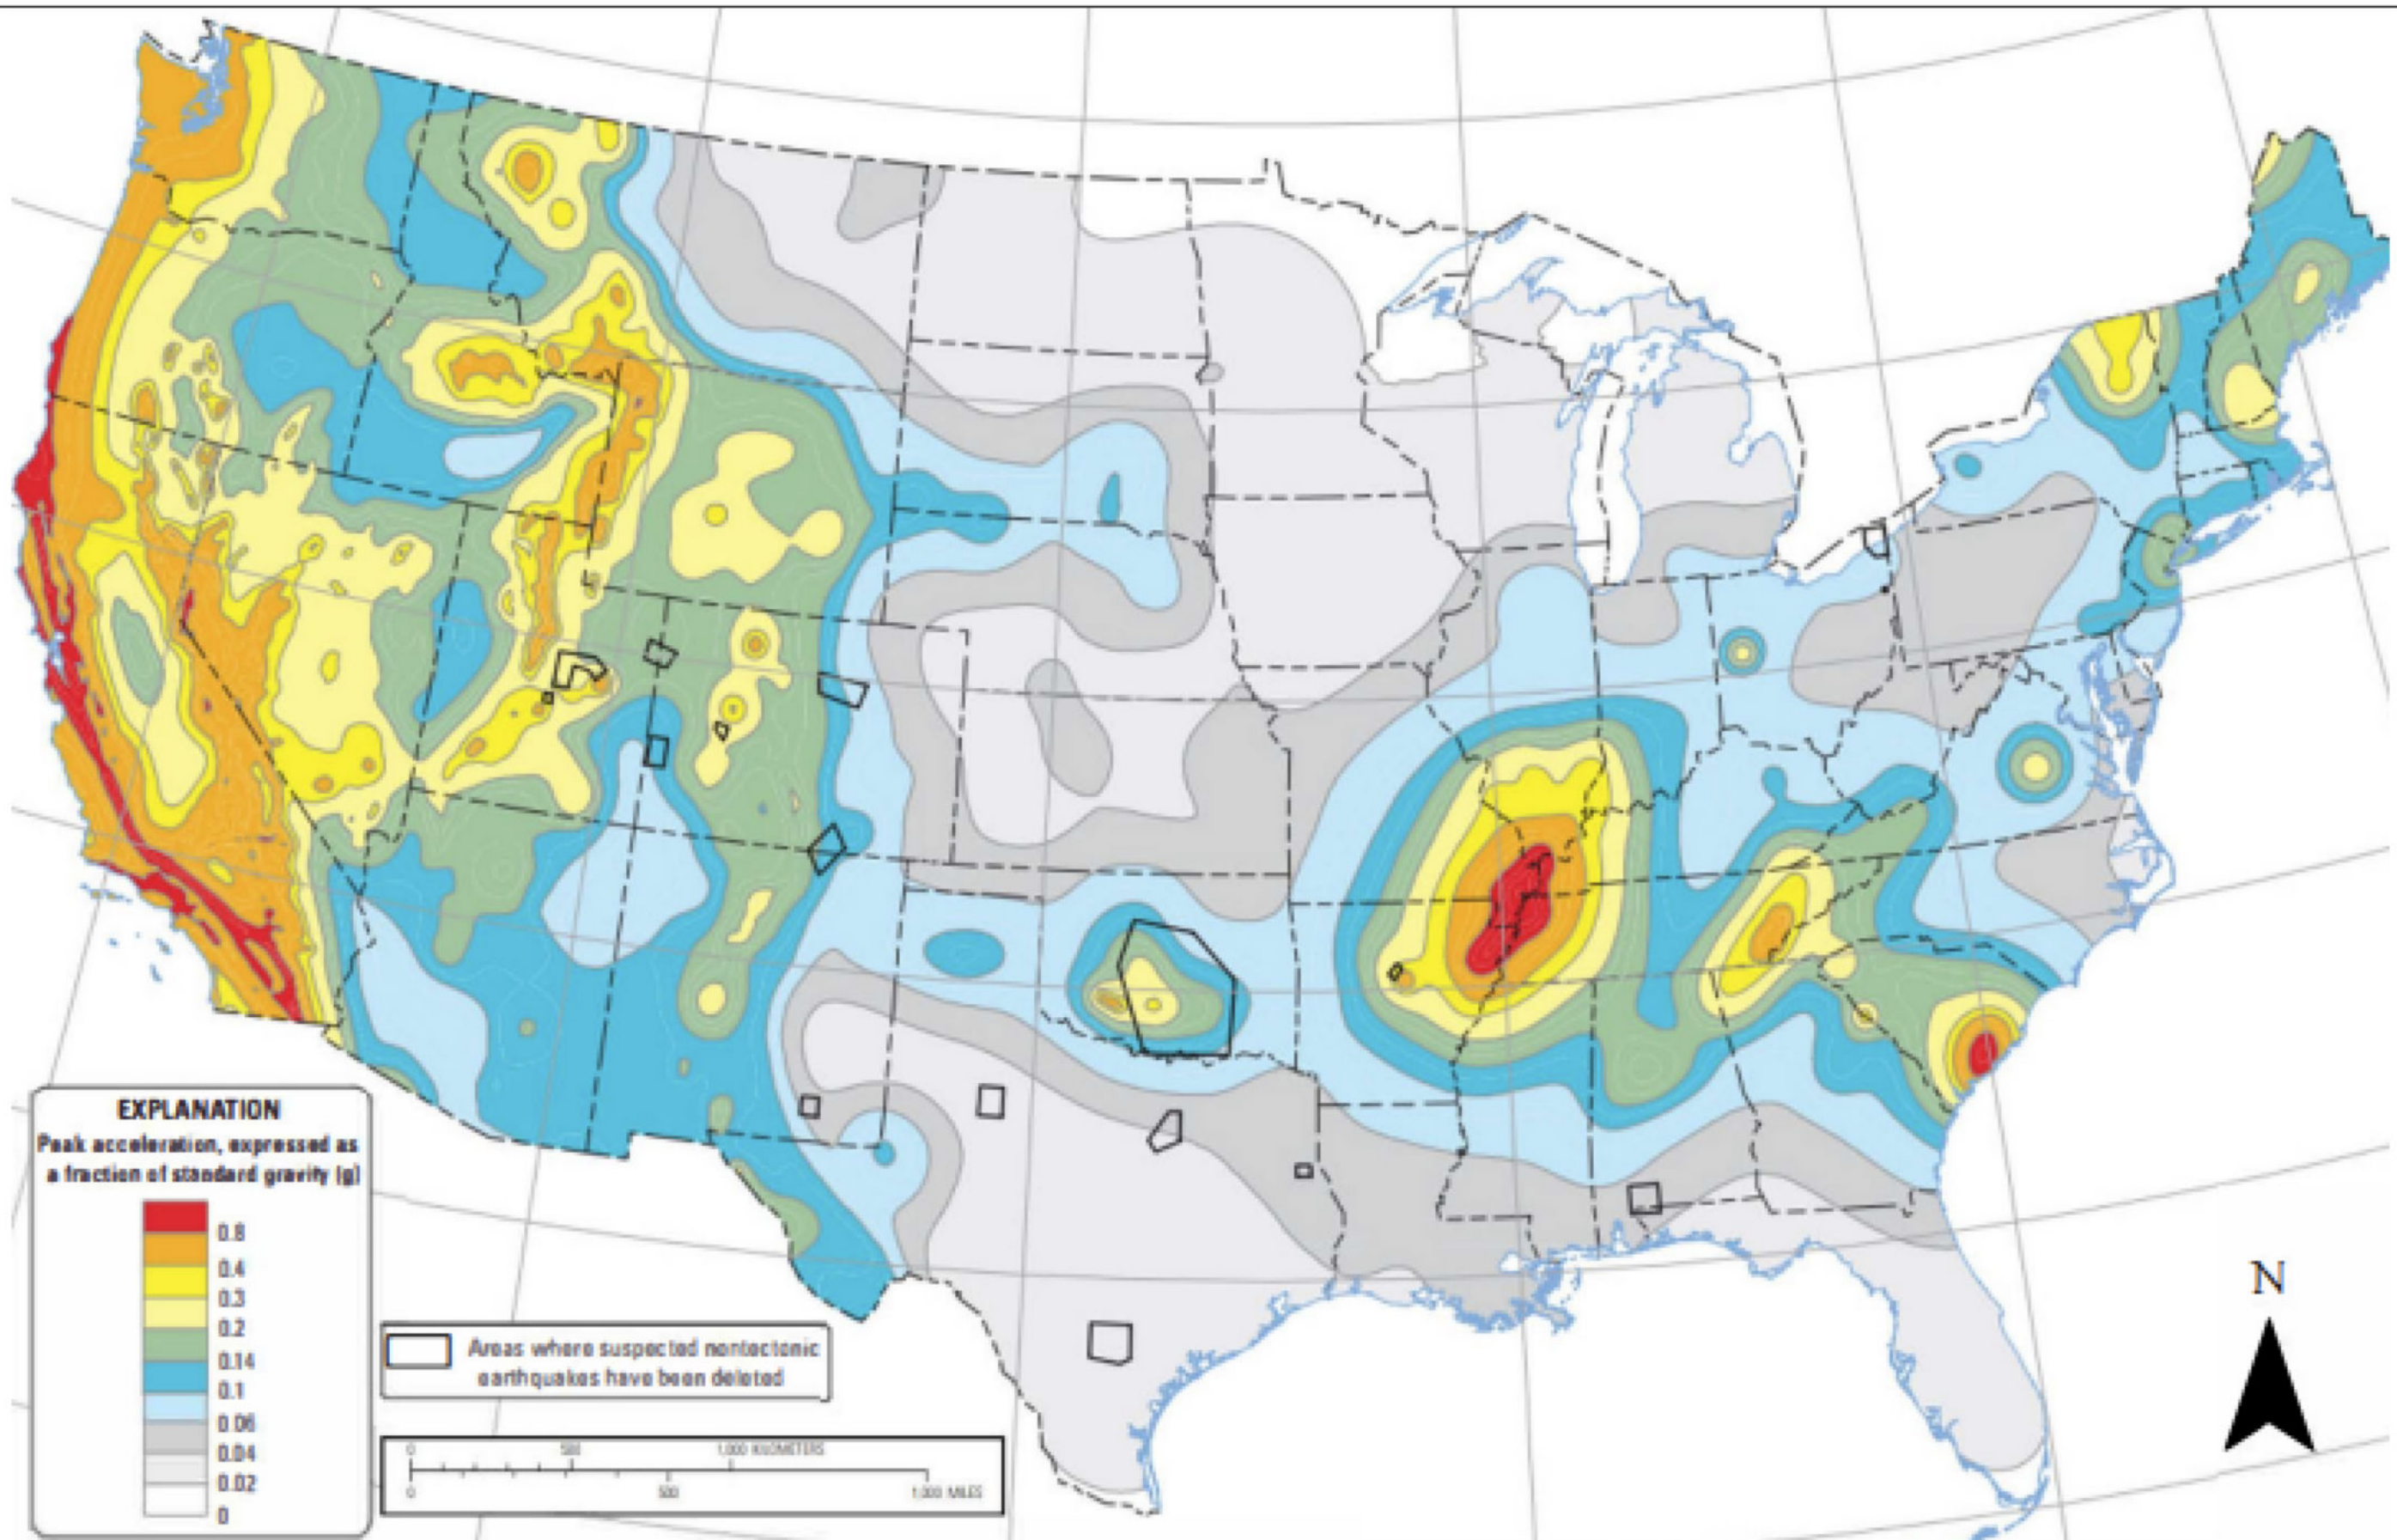
# Exhibit 2 - Earthquake Probability Map (Peak Acceleration (%g) with 2% Probability of Exceedance in 50 Years)

Source: USGS Earthquake Probability Map

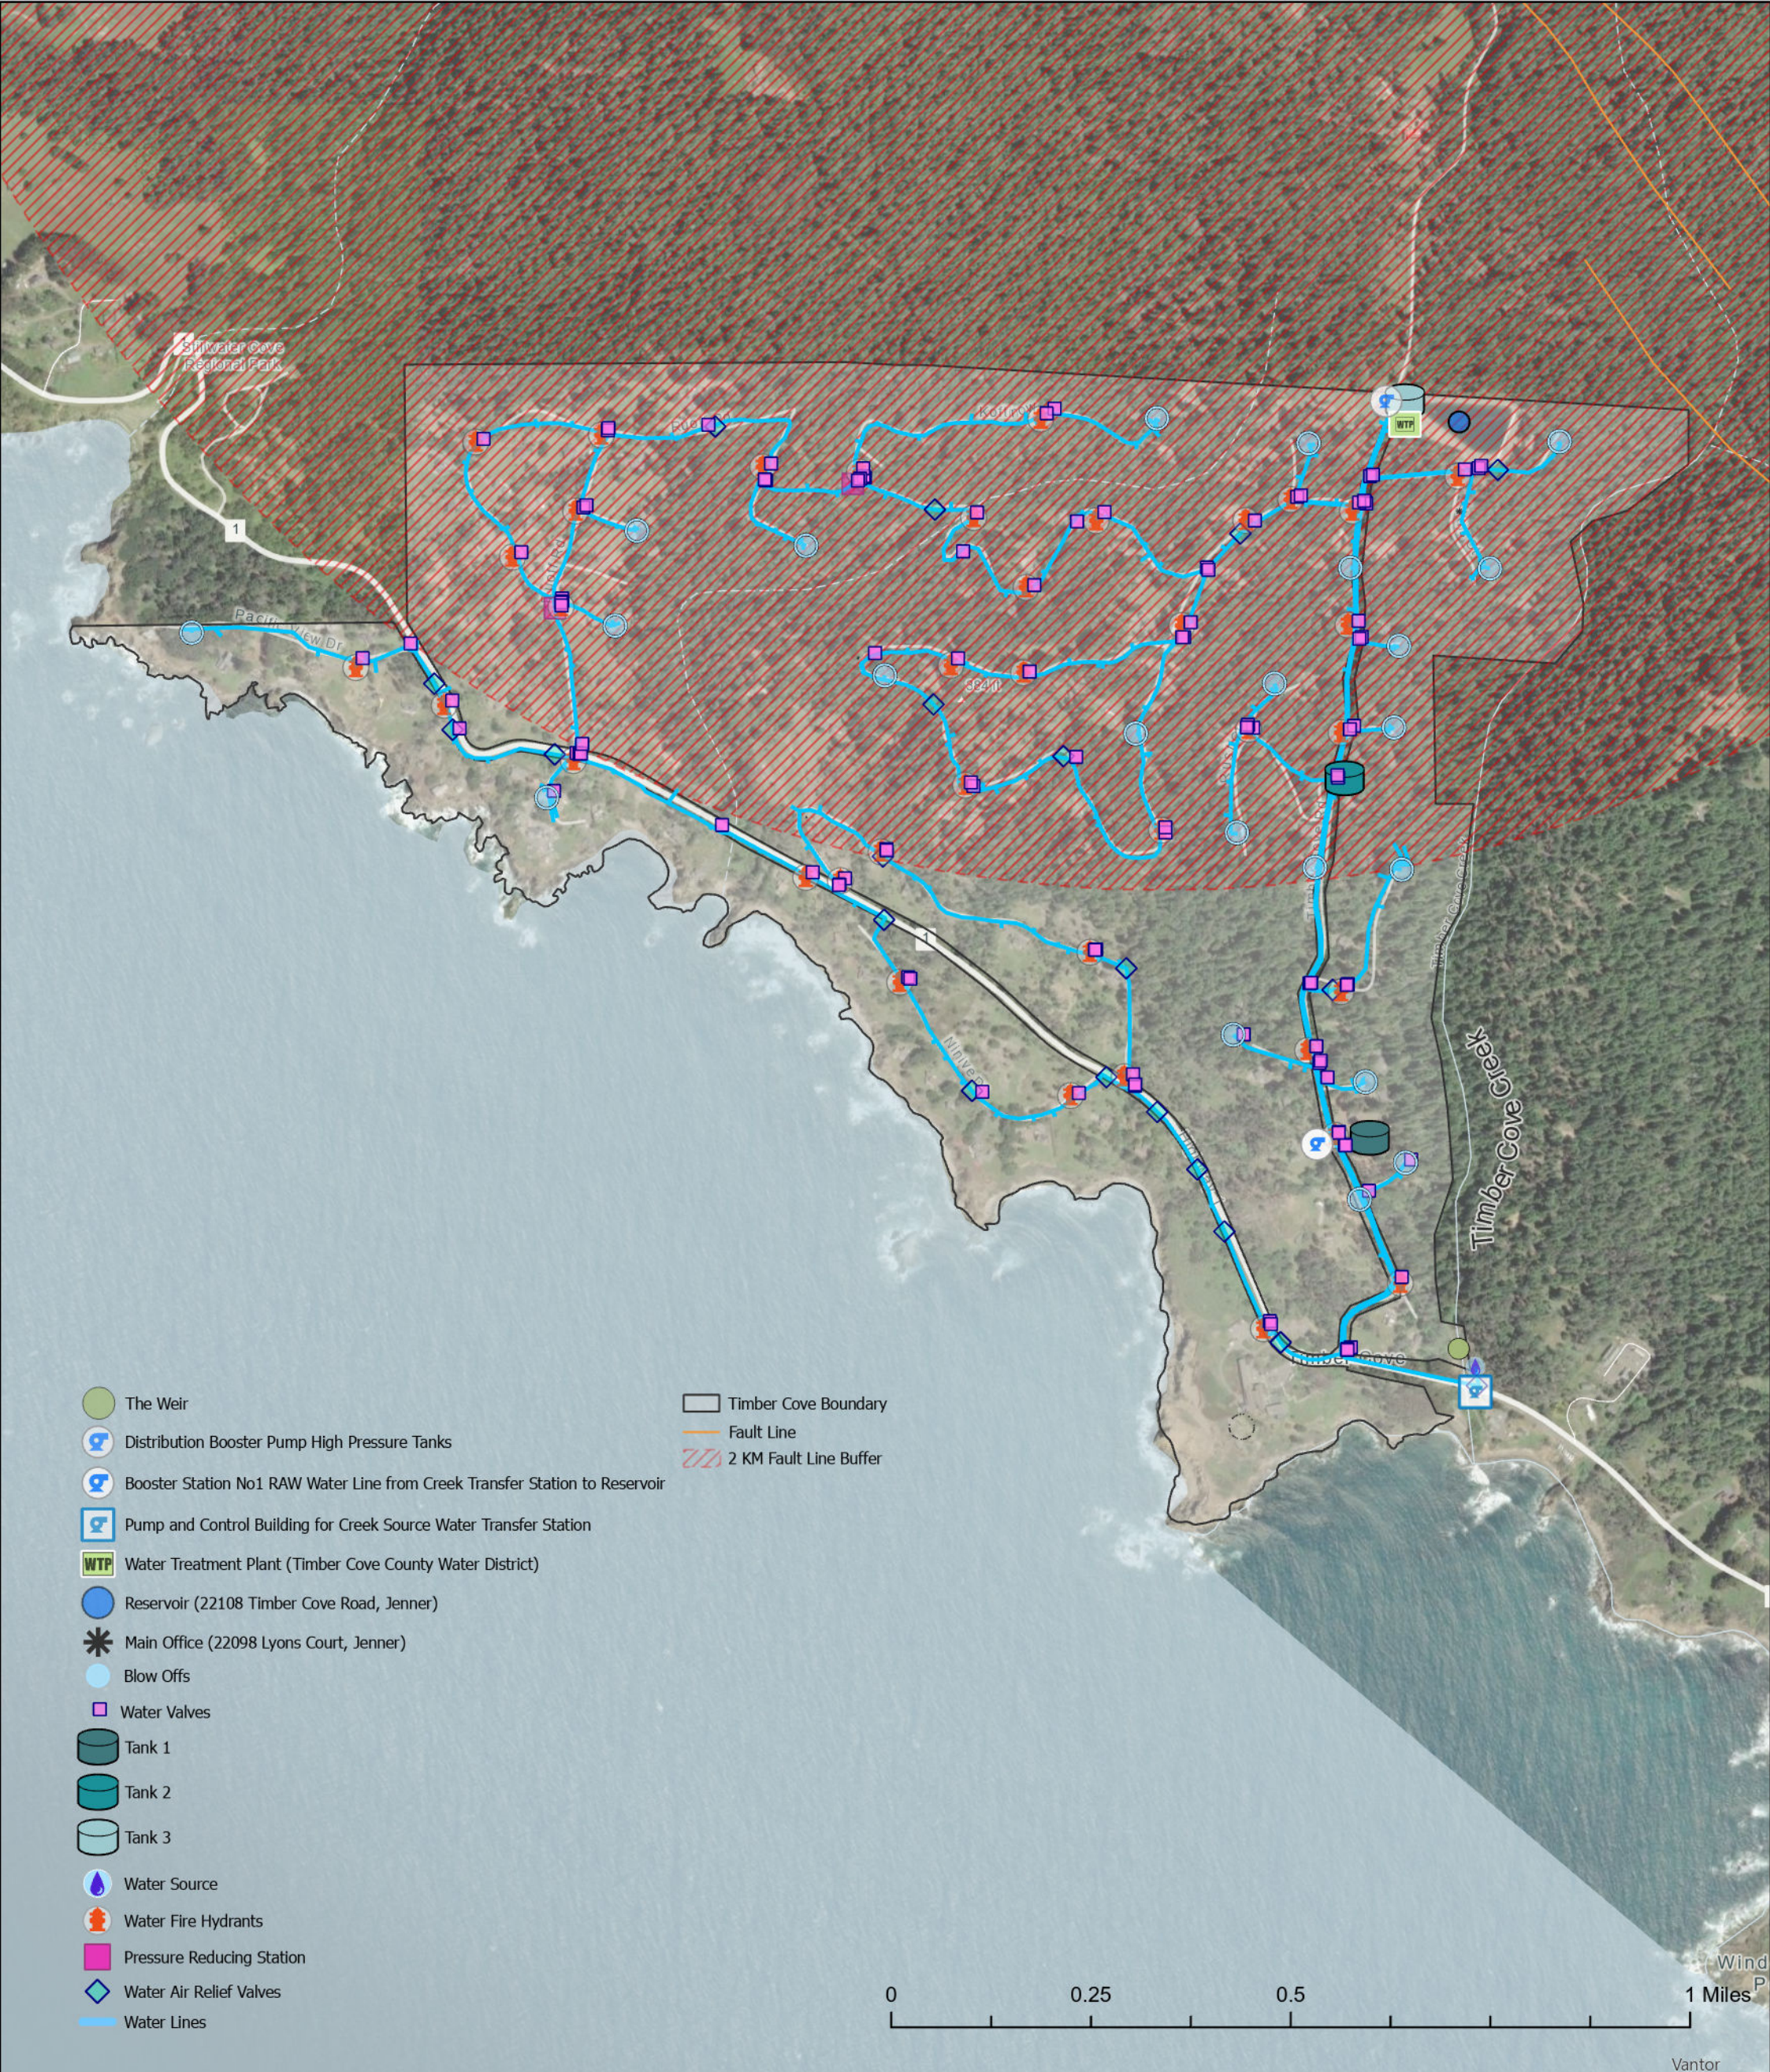
# Exhibit 4 - Earthquake Zones Adjacent to Timber Cove

Source: CalOES 2025

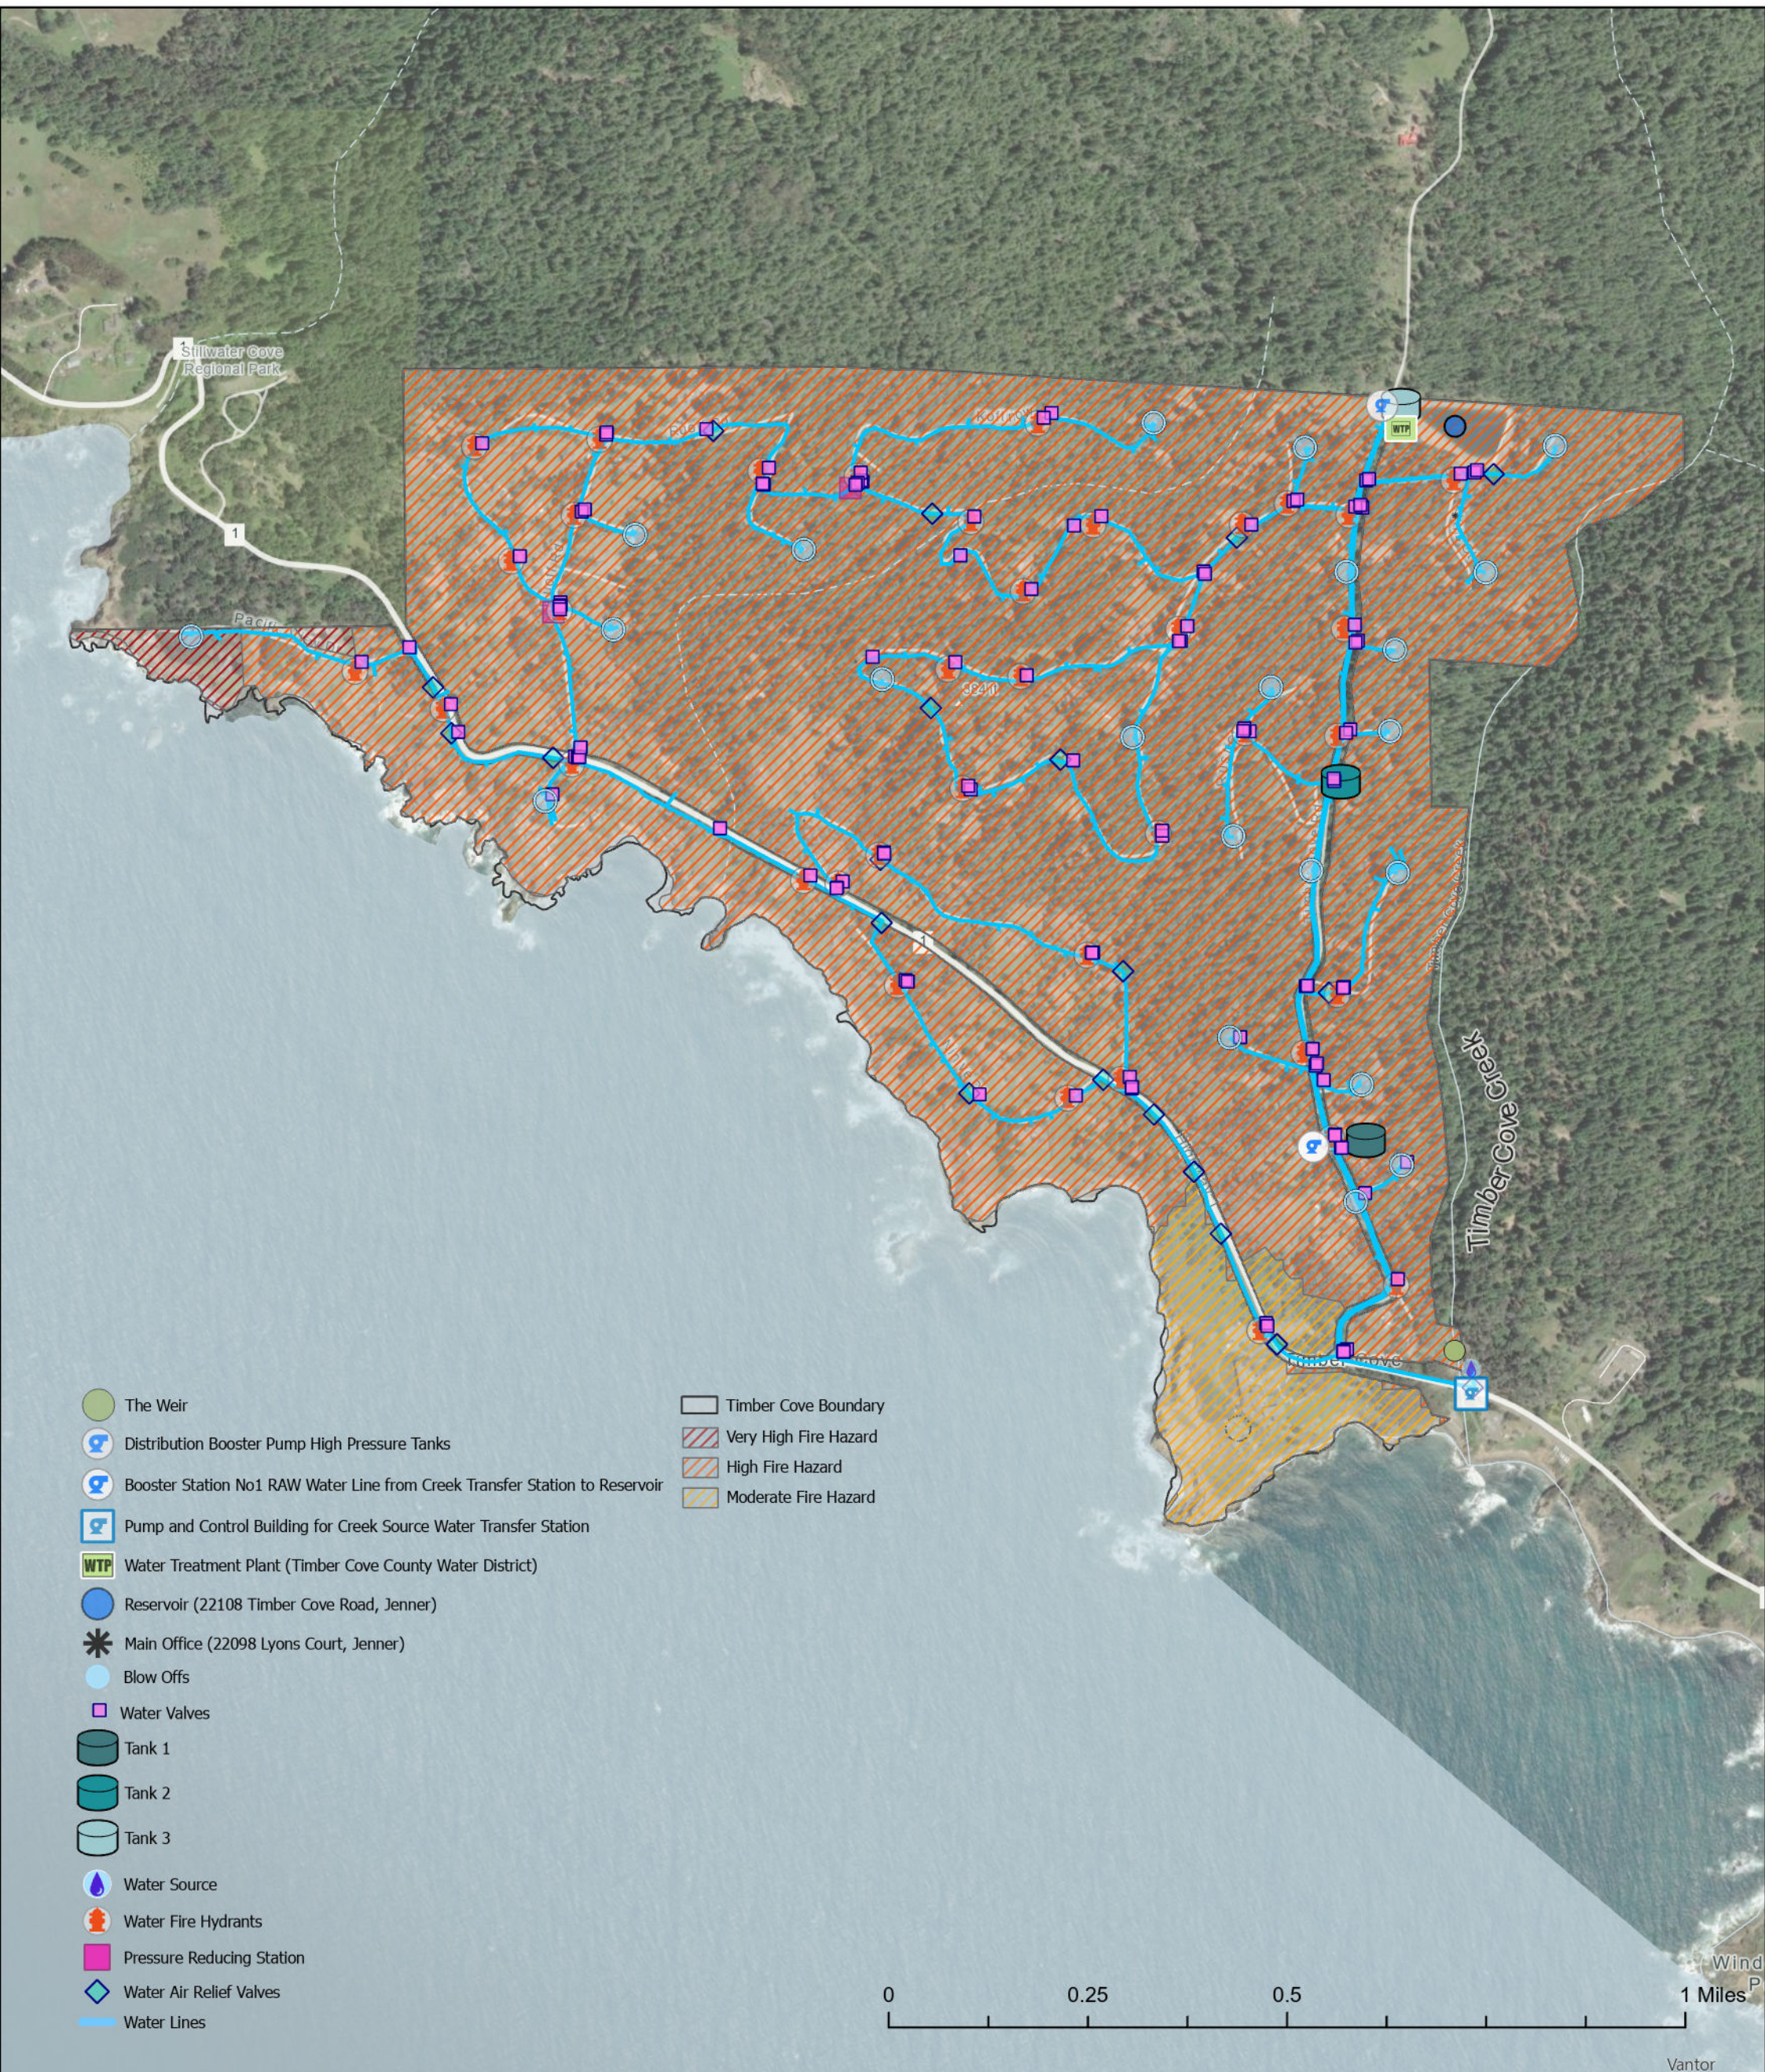
# Exhibit 5 - Fire Hazard Severity Zones

- The Weir
- Distribution Booster Pump High Pressure Tanks
- Booster Station No1 RAW Water Line from Creek Transfer Station to Reservoir
- Pump and Control Building for Creek Source Water Transfer Station
- WTP Water Treatment Plant (Timber Cove County Water District)
- Reservoir (22108 Timber Cove Road, Jenner)
- Main Office (22098 Lyons Court, Jenner)
- Blow Offs
- Water Valves
- Tank 1
- Tank 2
- Tank 3
- Water Source
- Water Fire Hydrants
- Pressure Reducing Station
- Water Air Relief Valves
- Water Lines

- Timber Cove Boundary
- Very High Fire Hazard
- High Fire Hazard
- Moderate Fire Hazard
