# **Draft Local Hazard Mitigation Plan**

## **Timber Cove County Water District**

**Timber Cove County Water District**  
22098 Lyons Ct,  
Jenner, CA, 95450

**BKF, Inc.**  
100 Franklin St #4c,  
Oakland, CA 94612

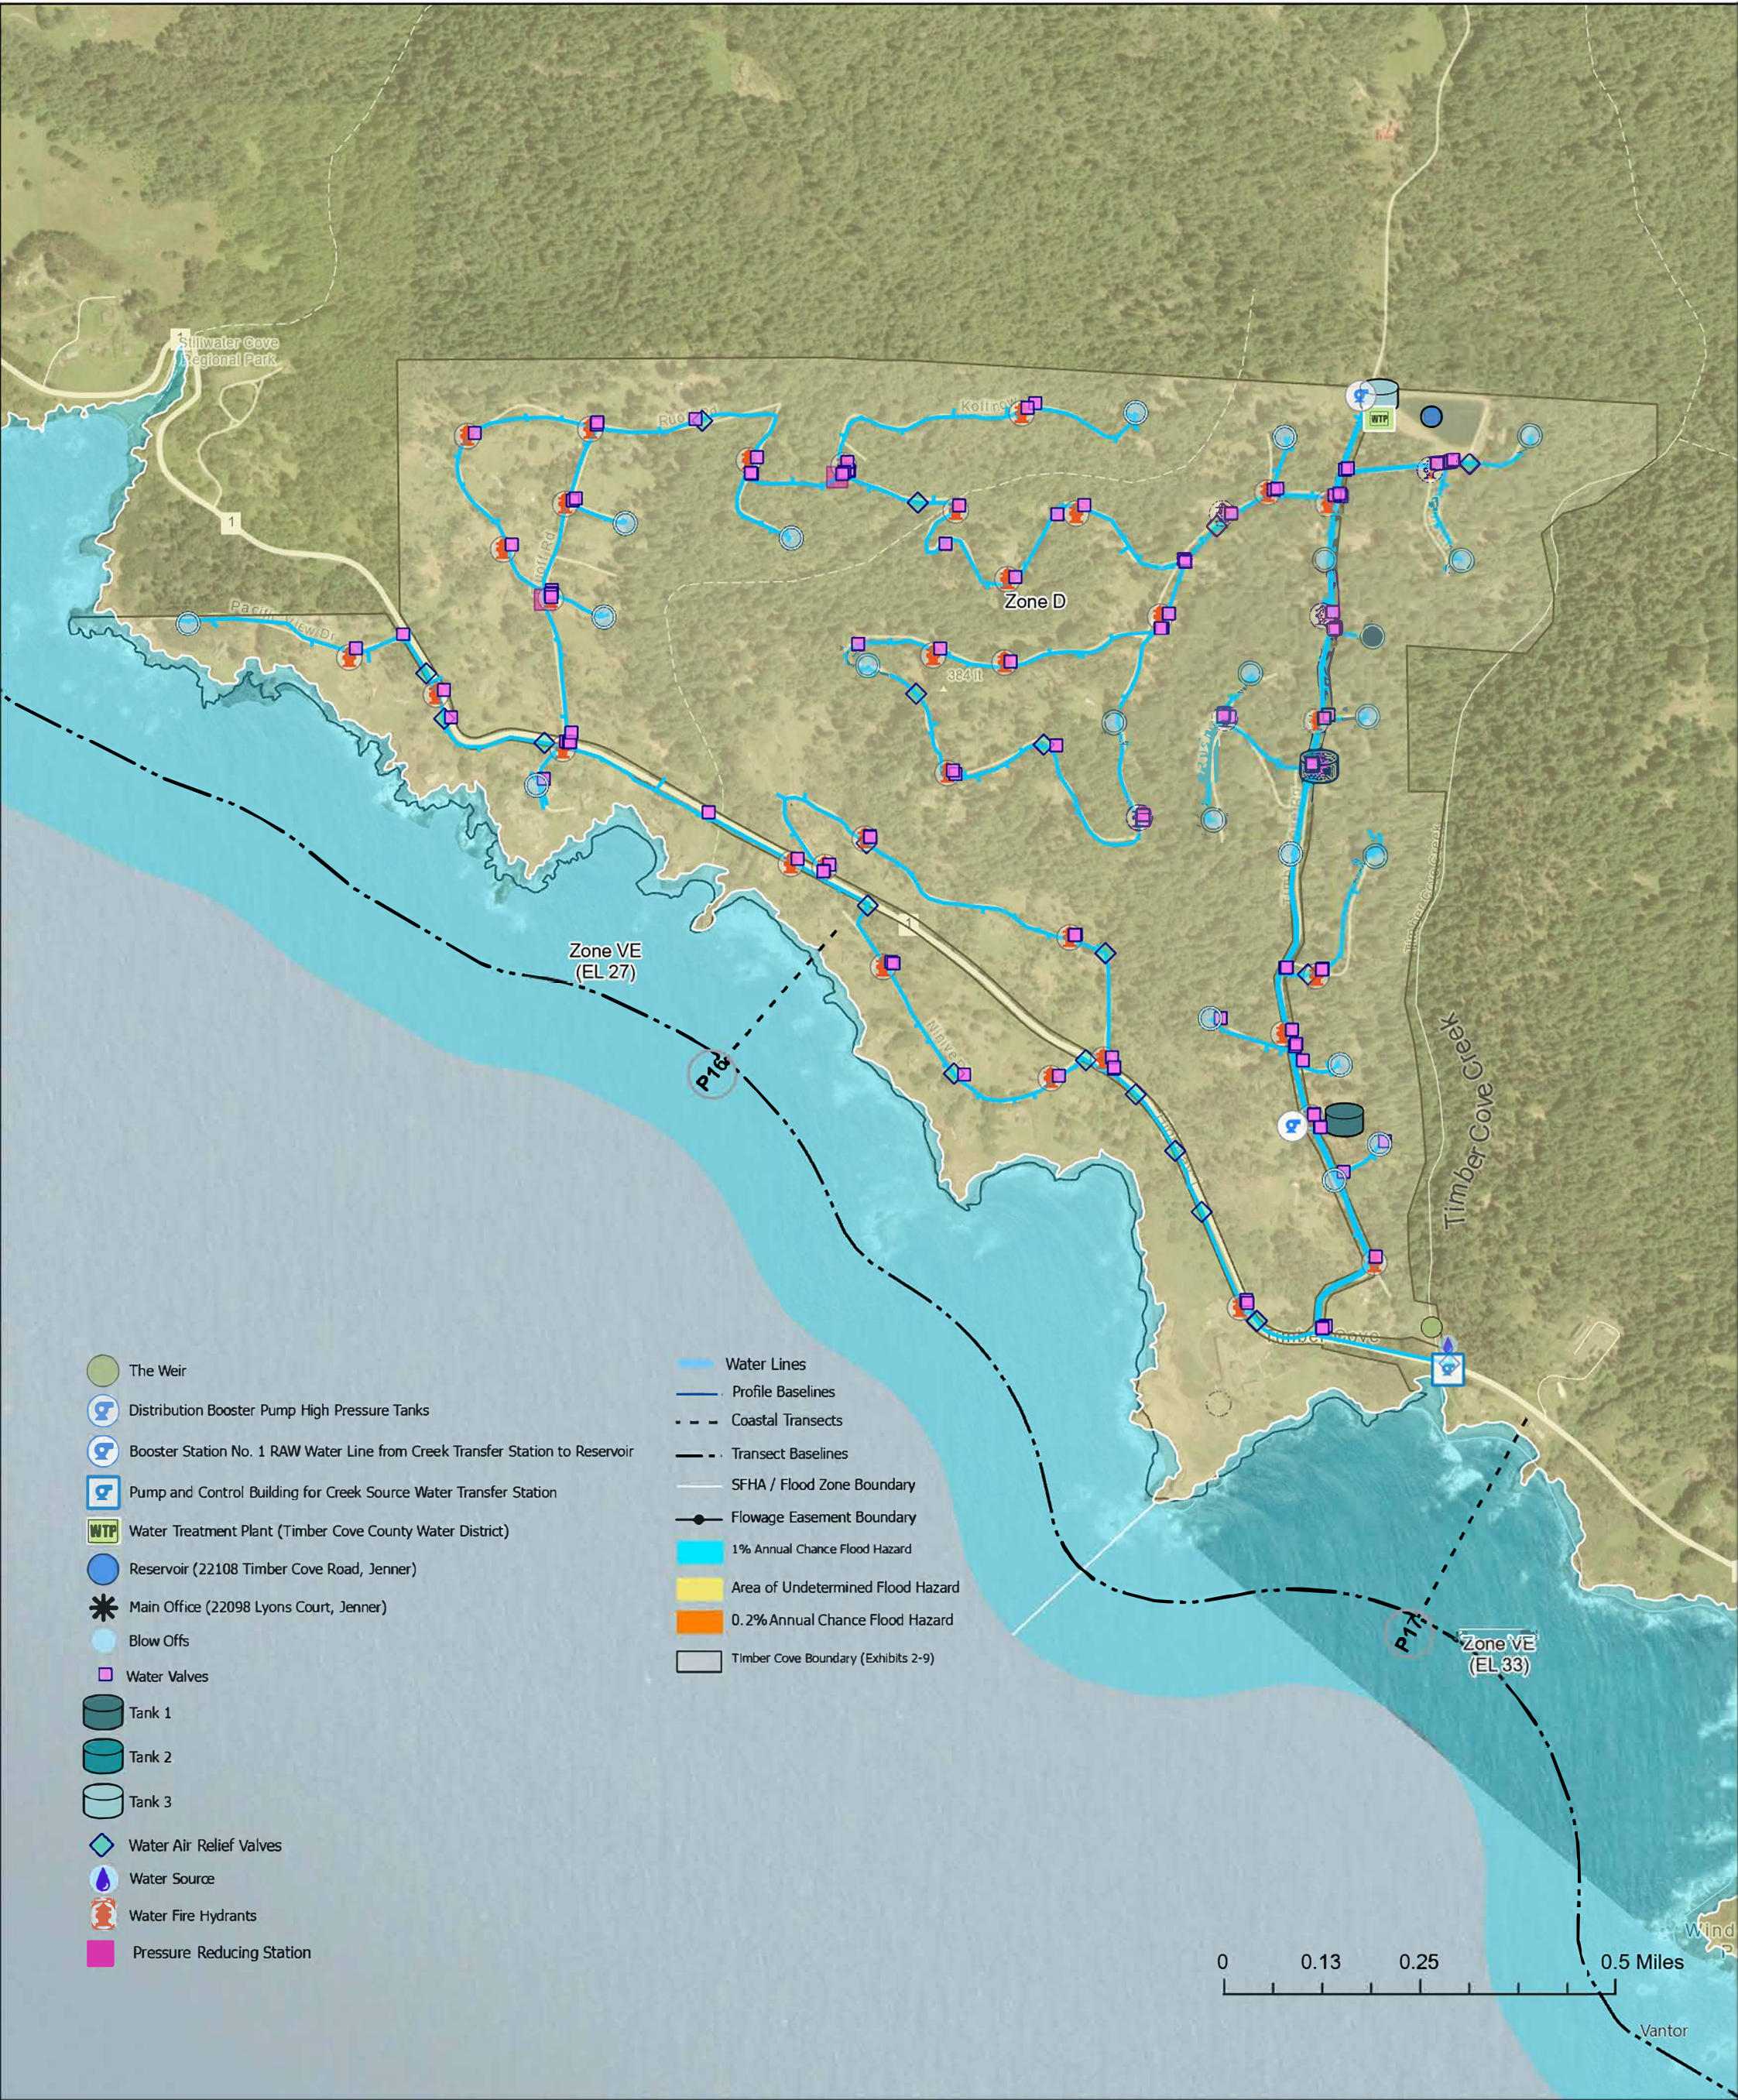
# Exhibit 7 - FEMA Flood Hazard Map

Source: FEMA Flood Service Map

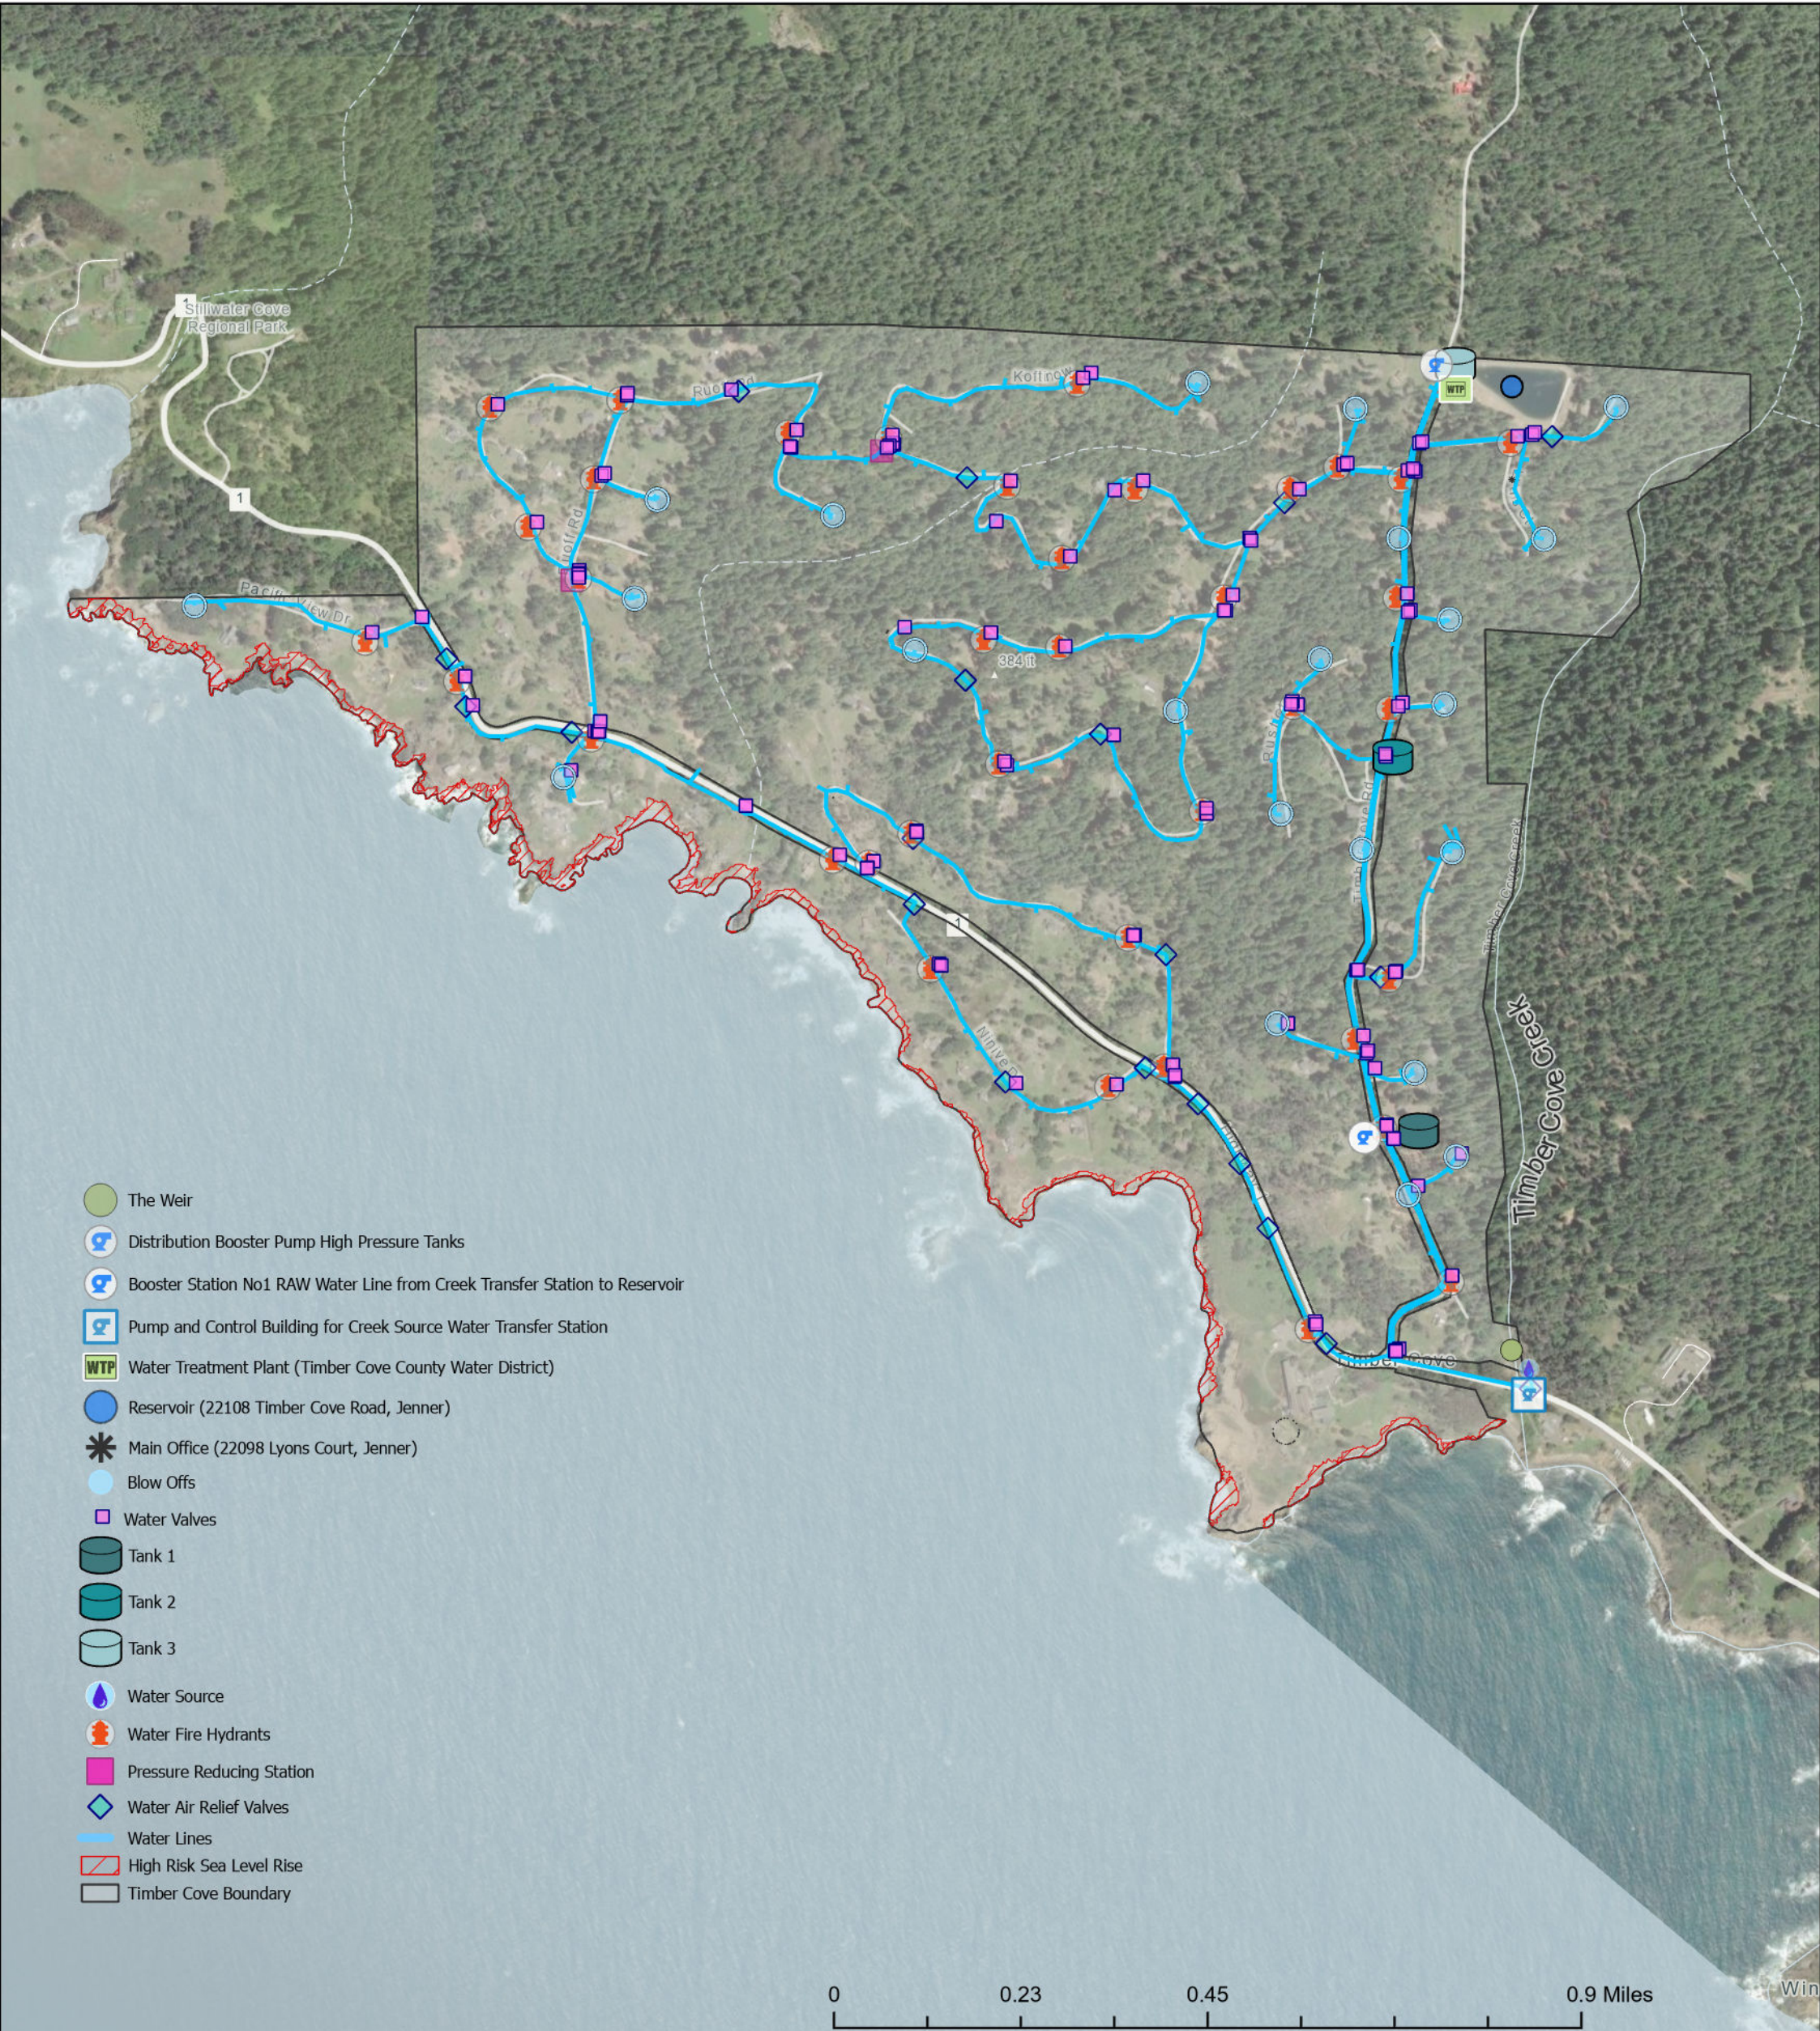
# Exhibit 8 - Estimated Inundation Area for 200-centimeter Sea Level Rise with the 100-Year Storm

Source: CalOES 2025

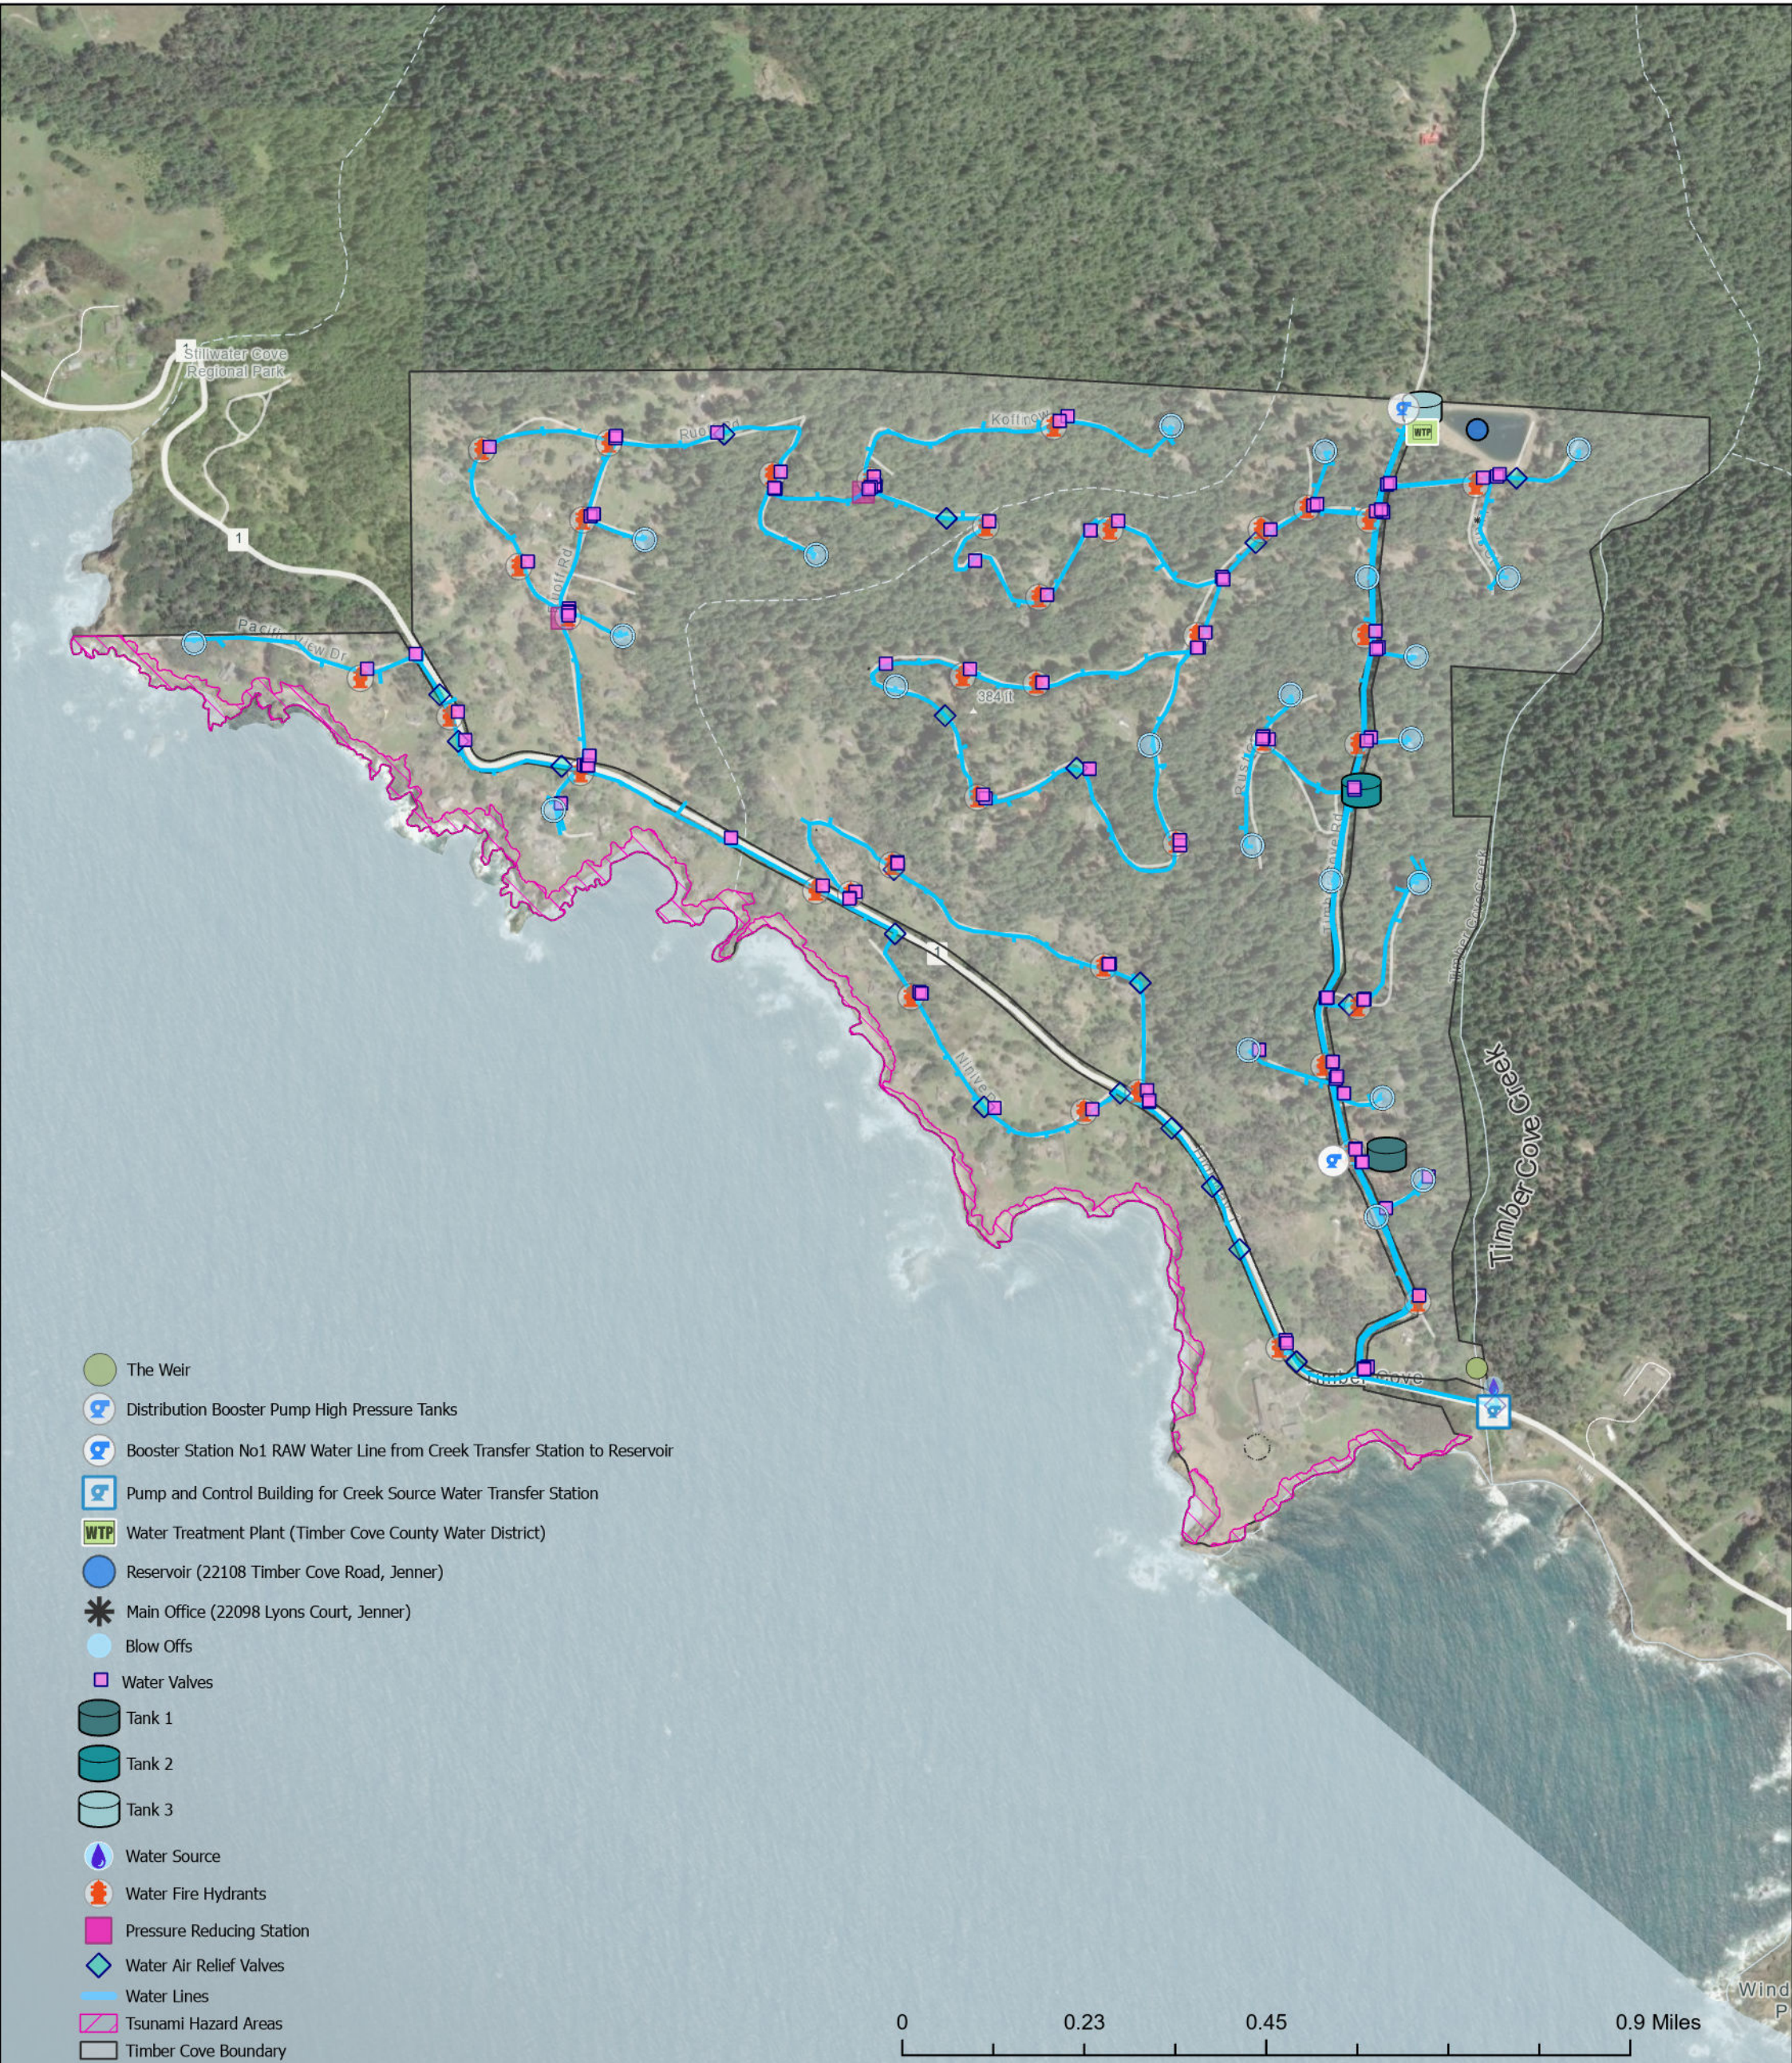
# Exhibit 9 - Predicted Tsunami Hazard Area

Source: CalOES 2025
